CHRONOLGY OF THE TRAMONTO / REVELLO LANDSLIDES

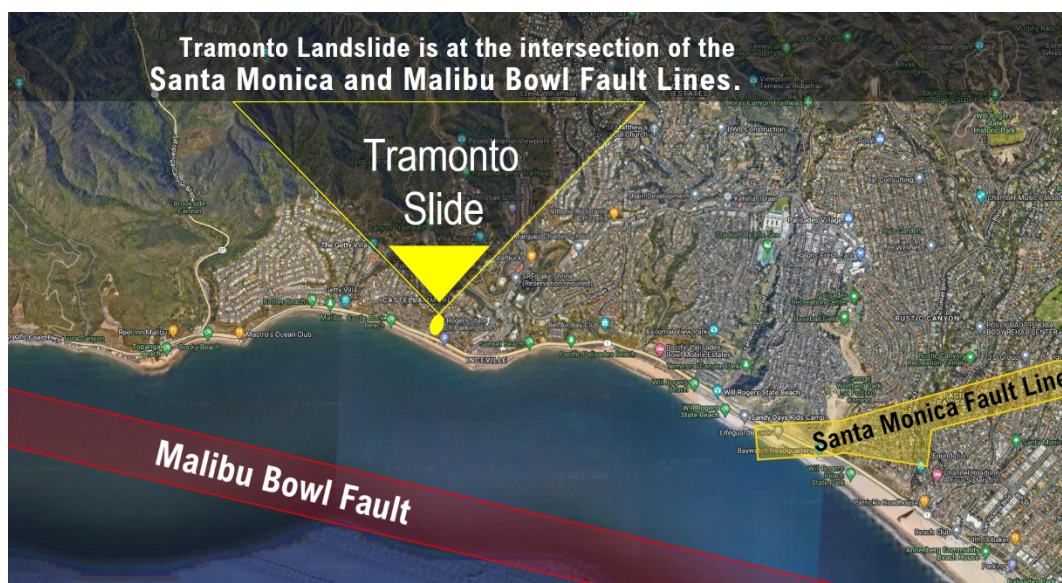
The URS report suggested using solid reinforced concrete to the elevation of the hydraugers. The report showed that there should be structural-support elements in place besides just excavating to the level of the bedrock. The cost to reinforce that Tramonto slide area was estimated to be about \$25 million in July 2010. The report showed a deep-bedrock failure plane between Posetano and Tramonto. That bedrock plane also feeds into the Malibu Coast-Santa Monica Earthquake Fault Line.

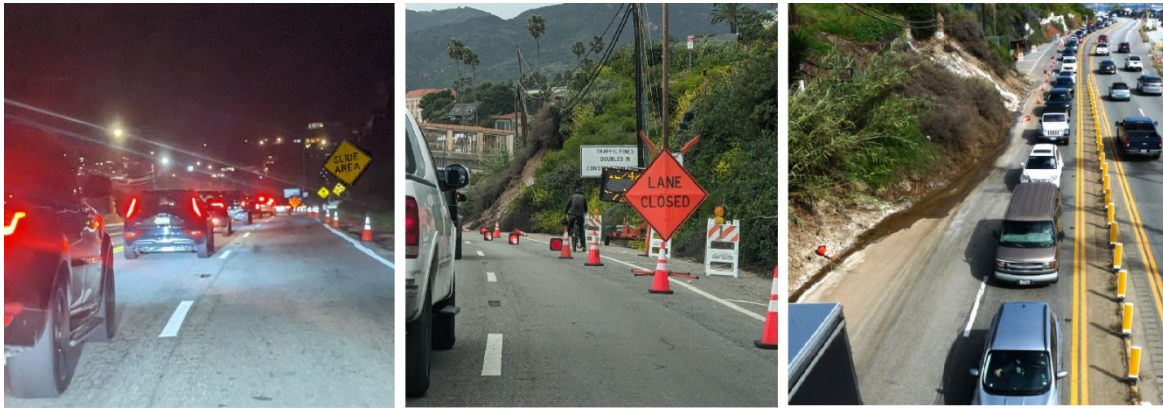
landslide stabilization measures. Unfortunately, the City of Los Angeles has ignored these findings and recommendations.

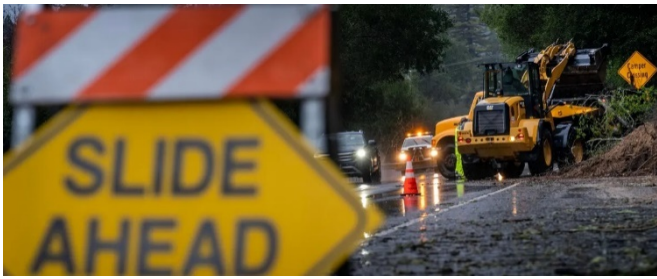
ARTIFICIAL INTELLIGENCE SEARCHES THE INTERNET TO FIND THE ANSWER TO COMPLEX QUESTIONS. HERE IS WHAT IT HAS TO SAY ABOUT BUILDING ON AN ACTIVE LANDSLIDE.
